A. Komornik, Faculty of Civil Engineering, Technion, Israel Institute of Technology
J.M.Amir, Foundation Control Institute, Ramat Hasharon, Israel

The paper describes the chain of events related to the construction of the piles carrying pier NB-2 of the Ayalon Highway over the period April to September 1992. From the start, construction of the piles was accompanied by various difficulties. As a result the integrity testing programme was extended to include practically all the methods presently available: Sonic echo testing, cross-hole ultrasonic logging, gamma-ray scattering, open excavation and core drilling. After serious defects were found in six of the nine piles, the client decided on remedial measures. These consisted of pressure grouting through holes that were specially drilled, as well as through the same steel tubes previously installed for testing. Subsequent integrity testing showed little effect, but Statnamic load testing, carried out on all the piles, demonstrated their capacity.

The Northbound (NB) bridge is part of the Ayalon Highway which crosses Tel Aviv in the North-South direction. The foundation for Pier NB-2 of the bridge includes nine bored piles, cast in-

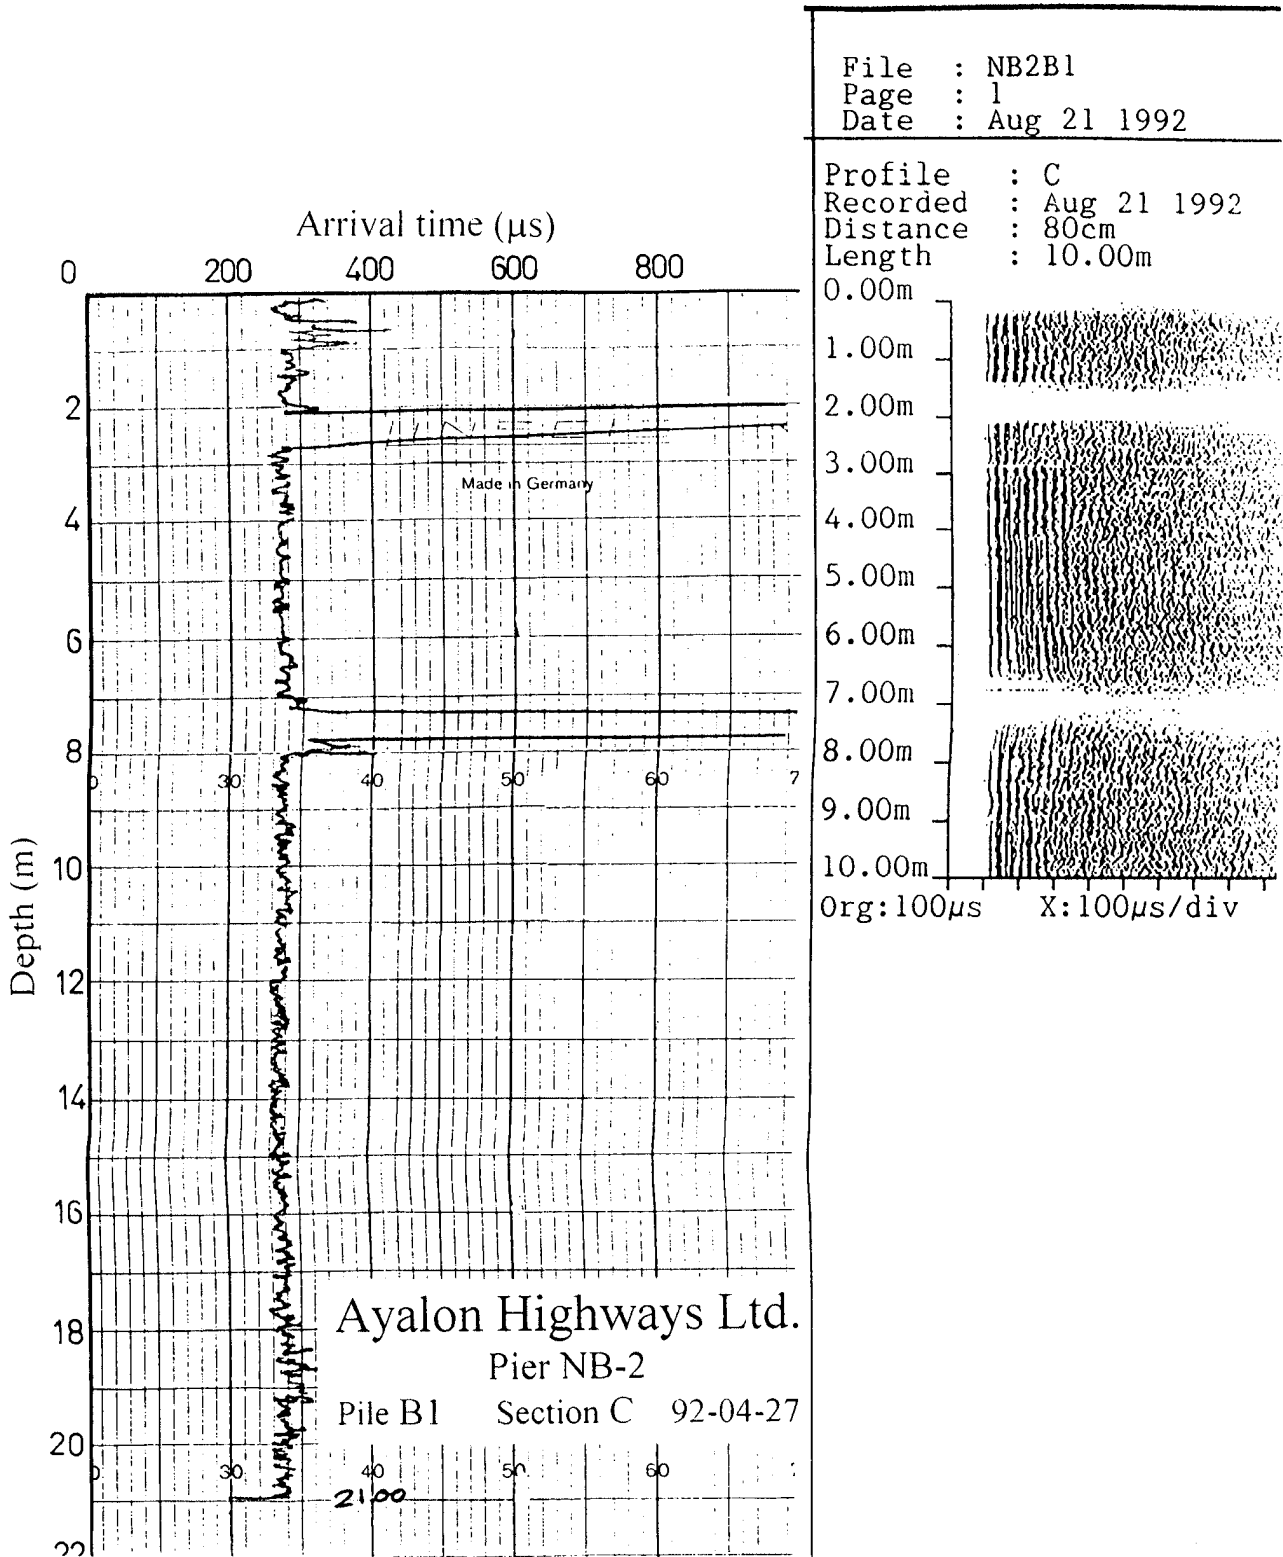
Figure 6: Result of Ultrasonic Testing Before Repair (Left) and After Repair (Right)

Towards the end of April, as soon as the debris and the drilling mud were removed and the steel tubes opened and straightened, all piles were tested by analog ultrasonic equipment. The existence of four tubes in each of the piles enabled altogether the testing of six sections per pile, with almost full coverage of the pile volume. As testing operations progressed, it became obvious that pier NB-2 is afflicted by irregularities, with serious defects, sometimes at two or three distinct levels, observed in six of the piles (Table 1). Since defects were found in both the sides and the diagonals of the tube layout, it was concluded that defects exist not only close to the skin, but also inside the piles.

As to the cross-hole logging, direct before-after comparison was difficult since in the meantime the old analog equipment was replaced by a new computerized unit. Nevertheless, the test results (Figure 6) again showed little effect of the repair.
