A. Komornik, Faculty of Civil Engineering, Technion, Israel Institute of Technology  
J.M.Amir, Foundation Control Institute, Ramat Hasharon, Israel

The paper describes the chain of events related to the construction of the piles carrying pier NB-2 of the Ayalon Highway over the period April to September 1992. From the start, construction of the piles was accompanied by various difficulties. As a result the integrity testing programme was extended to include practically all the methods presently available: Sonic echo testing, cross-hole ultrasonic logging, gamma-ray scattering, open excavation and core drilling. After serious defects were found in six of the nine piles, the client decided on remedial measures. These consisted of pressure grouting through holes that were specially drilled, as well as through the same steel tubes previously installed for testing. Subsequent integrity testing showed little effect, but Statnamic load testing, carried out on all the piles, demonstrated their capacity.

The Northbound (NB) bridge is part of the Ayalon Highway which crosses Tel Aviv in the North-South direction. The foundation for Pier NB-2 of the bridge includes nine bored piles, cast i

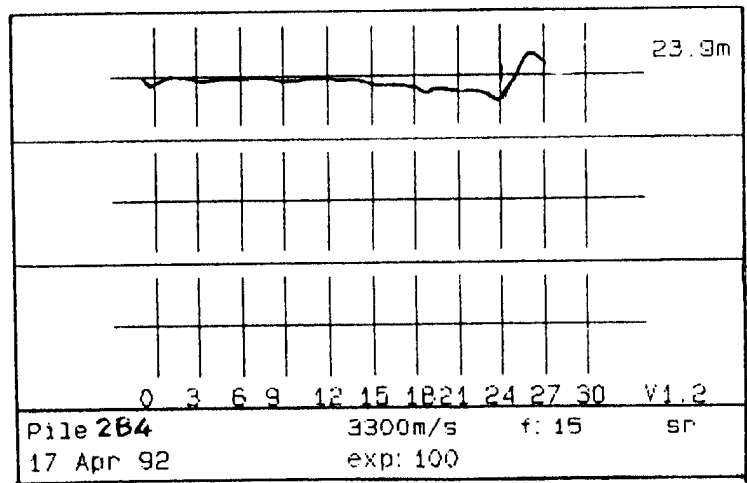
Figure 3: Result of Sonic Test - Pile B4

A few days after completion, the head of pile B4 was exposed and the pile was tested by the sonic echo method. The resulting reflectogram (Figure 3) indicated no irregularities.

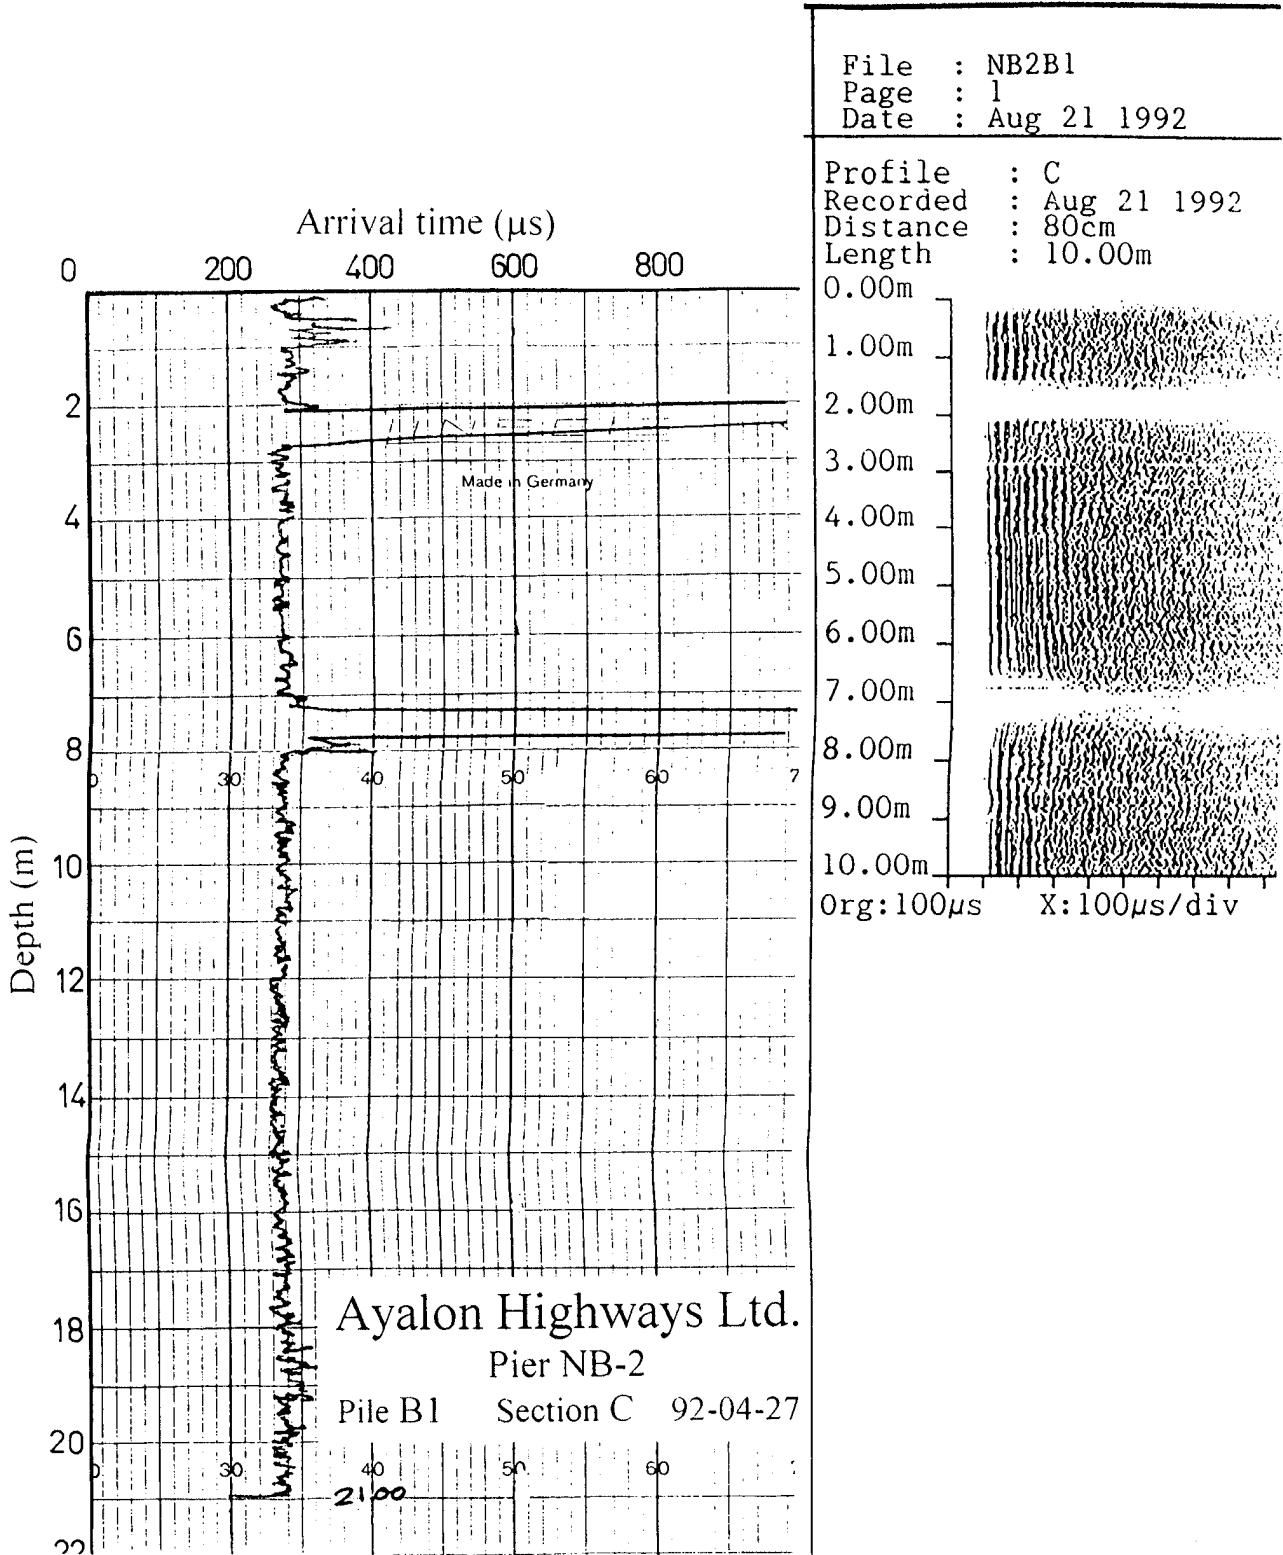
Figure 6: Result of Ultrasonic Testing Before Repair (Left) and After Repair (Right)

Towards the end of April, as soon as the debris and the drilling mud were removed and the steel tubes opened and straightened, all piles were tested by analog ultrasonic equipment. The existence of four tubes in each of the piles enabled altogether the testing of six sections per pile, with almost full coverage of the pile volume. As testing operations progressed, it became obvious that pier NB-2 is afflicted by irregularities, with serious defects, sometimes at two or three distinct levels, observed in six of the piles (Table 1). Since defects were found in both the sides and the diagonals of the tube layout, it was concluded that defects exist not only close to the skin, but also inside the piles.

As to the cross-hole logging, direct before-after comparison was difficult since in the meantime the old analog equipment was replaced by a new computerized unit. Nevertheless, the test results (Figure 6) again showed little effect of the repair.

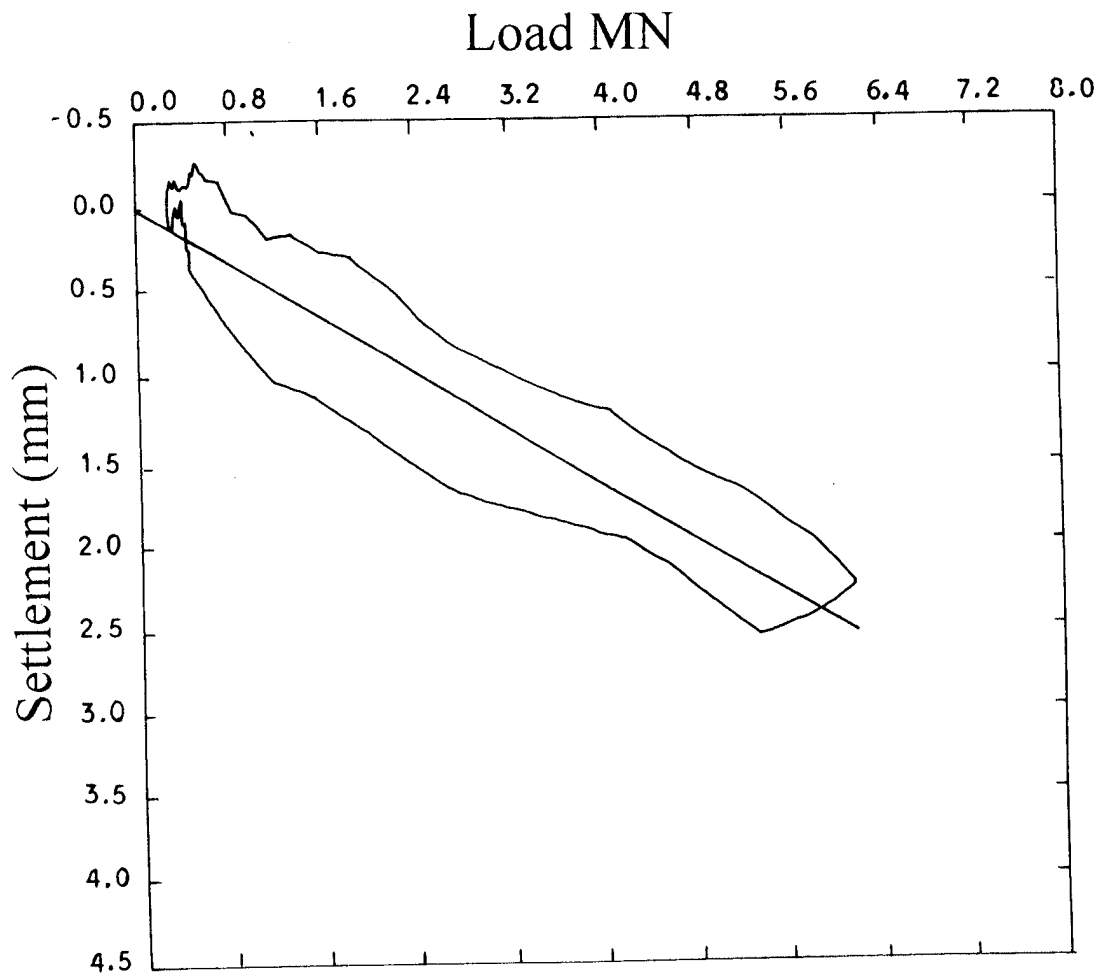
Figure 7: Results of Statnamic Loading Test on Pile A1

To verify the capacity of the repaired piles, the owner decided to subject the piles to a loading test. Due to time and space constraints, the Statnamic loading test appeared the only feasible alternative. All nine piles were tested during one week in September, with output ultimately reaching three tests per day. The applied loads reached a maximum of between 5.5 and 6.1 MN, with resulting deflections between 2.2 and 3.5 mm. All piles behaved elastically, with a net remnant settlement (Figure 7). The only exception was pile A2: Although considered free of defects, it showed a residual settlement of 1.5 mm.
